WASCANA CENTRE LANDSCAPE ASSESSMENT

FINAL REPORT

Submitted to
Wascana Centre Authority

By
Crosby Hanna & Associates

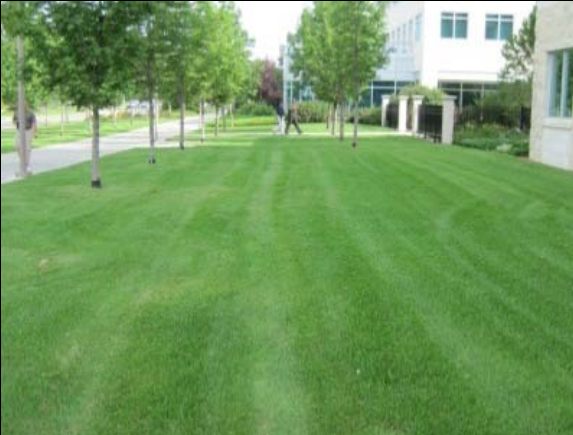
Good Condition: Good ground cover with few weeds.

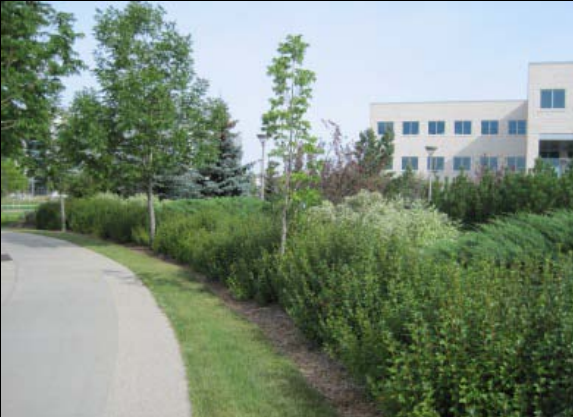
Good Condition: Small to medium sized shrubs have been selected. Shrub habit is dense and compact. Diversity of shrub species throughout beds. Bed has mulch ground cover.

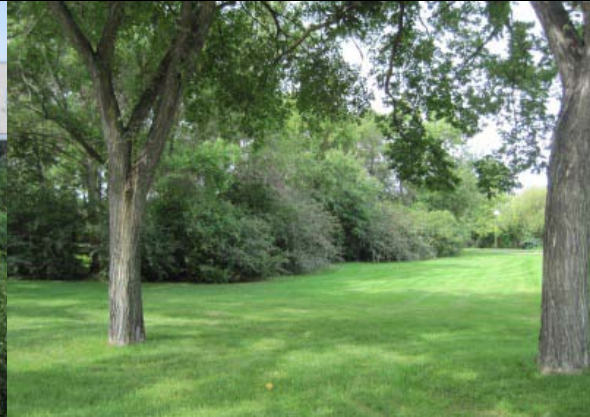
Good Condition: Shrub species retain a full and dense form when mature and overgrown.

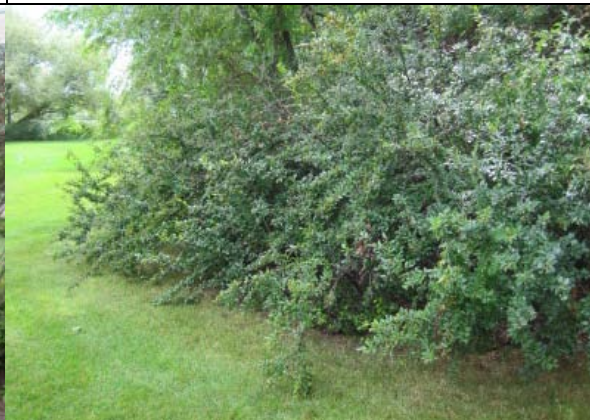
Problem: Overgrown shrubs exceeding shrub beds affect mowing.

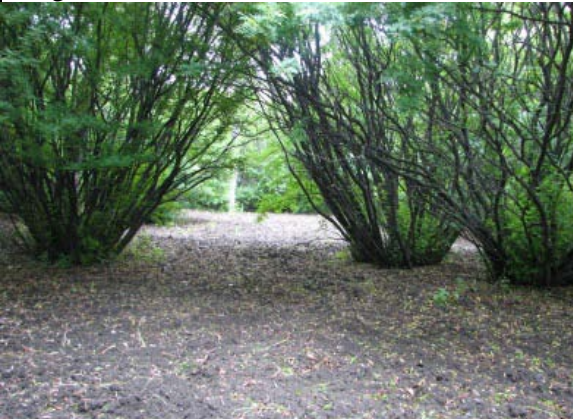
Problem: Long and leggy Caragana in a Rototilled bed.

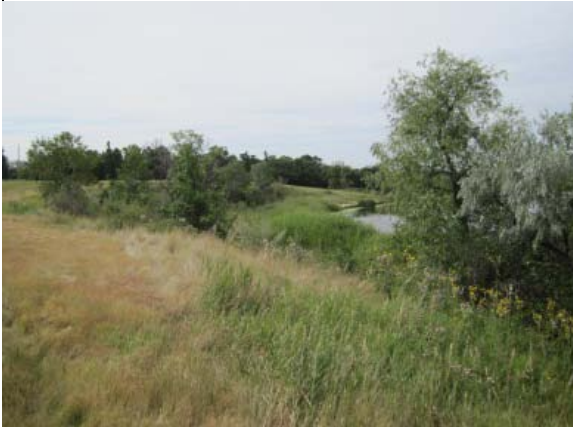
Good Condition: Established native plant species, including Willow, along the shoreline. Self propagation of native plant species is prevalent. Few weedy plants present.

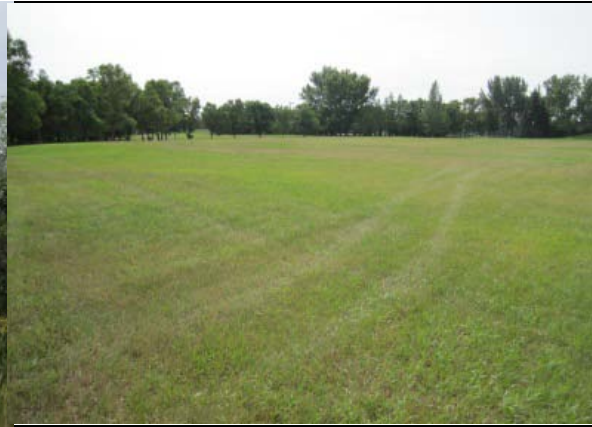
Good Condition: Good ground cover of dryland grass with few weeds

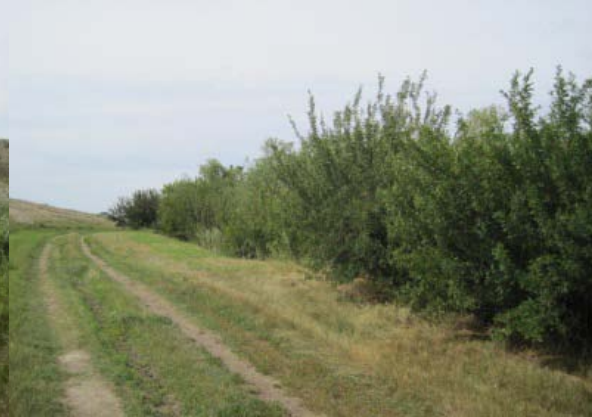
Another important concern is the prevalence of weedy or invasive species. These are mostly found in the naturalized areas. Especially concerning are the caragana that can be found along the shoreline, and noxious weeds that can be found in the naturalized grass areas.

Problem: Caragana invading the shoreline and choking out native species.

- Establish an invasive species list that should be eradicated
- Establish a Native Plant Stand rehabilitation plant list that could be used to aid naturalization efforts.
- Employ a long term restoration program to replace Caragana and other identified invasive species along all shorelines of Wascana Lake with a diverse population of native plant species to establish a healthy ecosystem along the lake edge.
- Maintain Native Plant Stands to ensure the continued suppression of invasive species.
- Implement a weed control program for dryland grass areas.

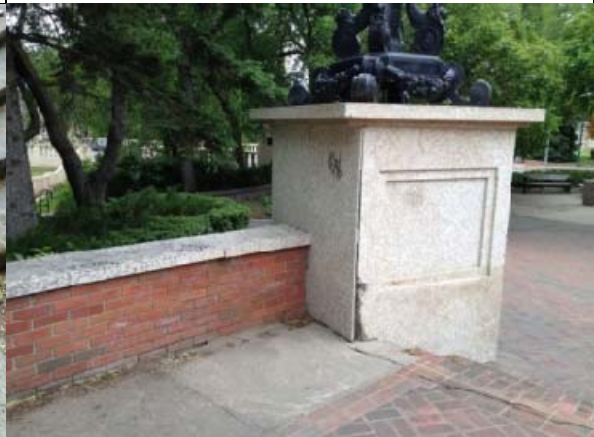
Photo 8: East Tyndall Stone Monument

- The concrete walkway at the north monuments has deteriorated (Photo 5).
- Some of the flat surfaces of on the south monuments were blackened (Photo 6), and some green stains were visible around the plaques (Photo 7).
- One corner of the Tyndall Stone at the base of the east statue has broken off (Photo 8).

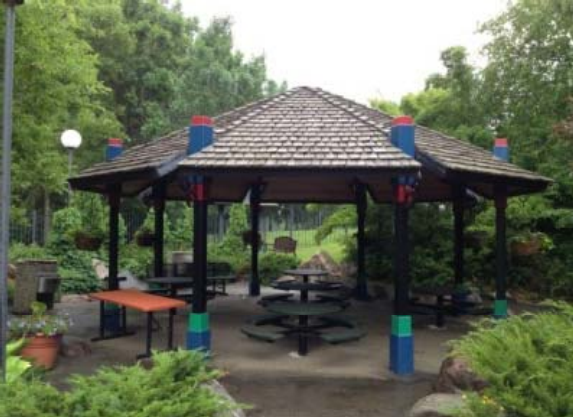
Photo 1: Gazebo

- Four structures were assessed; one gazebo with structural steel columns and wood roof (Photo 1), two steel gates with wood roofs (photo 2 & 3), and the perimeter steel fence (Photo 4).

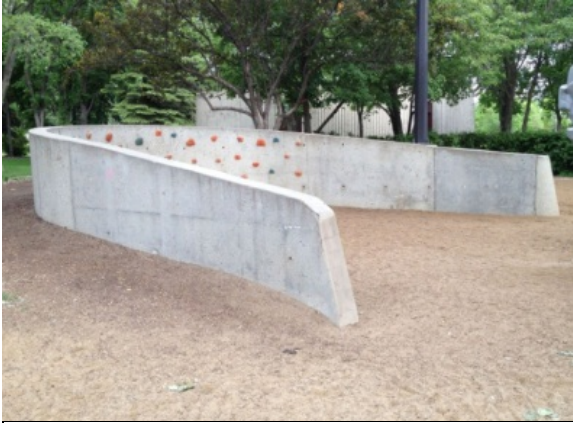
Photo 3: Concrete Retaining Wall

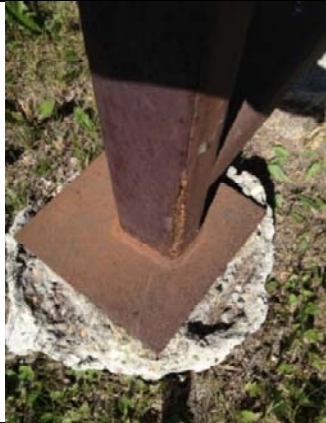
Photo 3: Split Leg in Steel Support

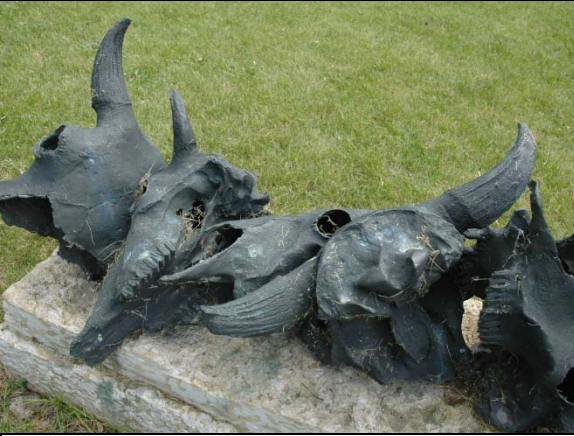
Example of patination discolouration, accretions and grass debris

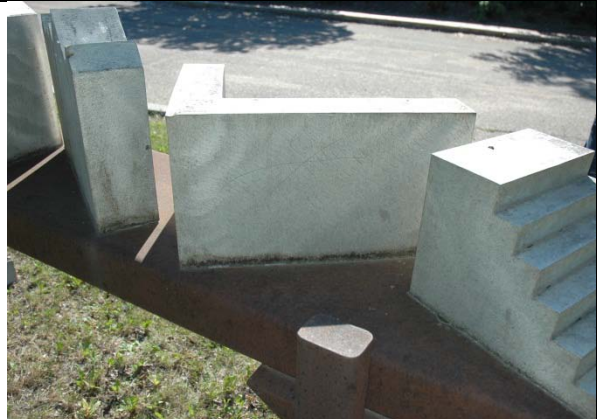
Example of scratches on structure surfaces

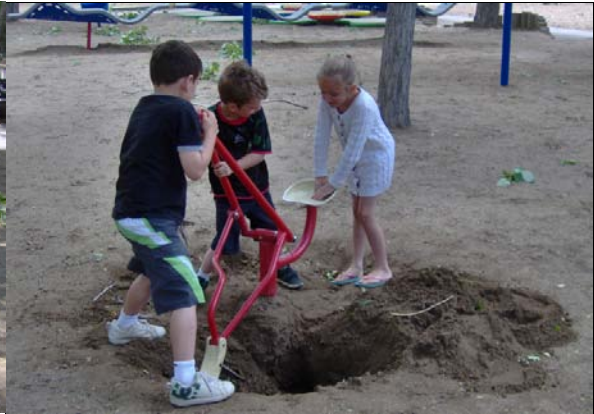
Back Hoe: Crush points on hinged parts

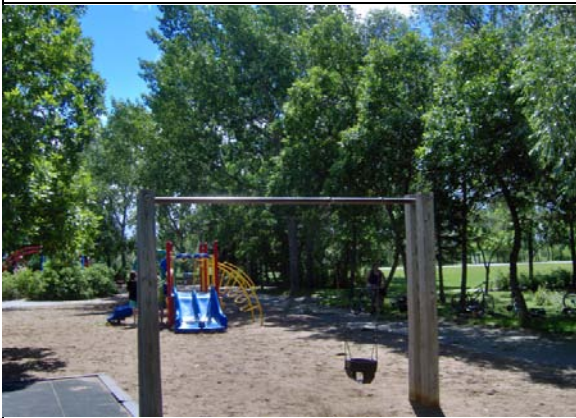
Swings: Elevated play surfaces

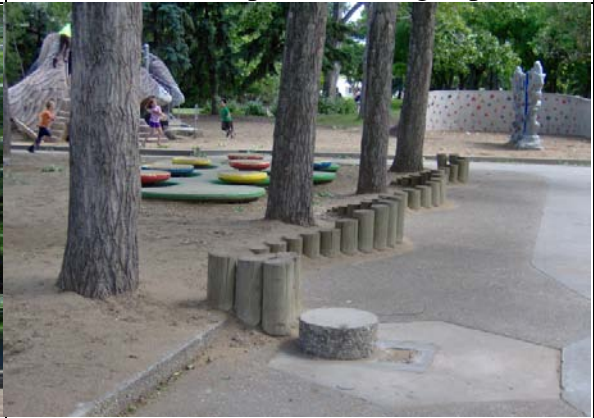
Post border: creates an elevated play surface
